Report No. UT-17.02

TYPICAL AND DARKENED PORTLAND CEMENT CONCRETE PAVEMENT: TEMPERATURE, MOISTURE, AND ROUGHNESS ANALYSES

Utah Department of Transportation
Research Division

Final Report
January 2017

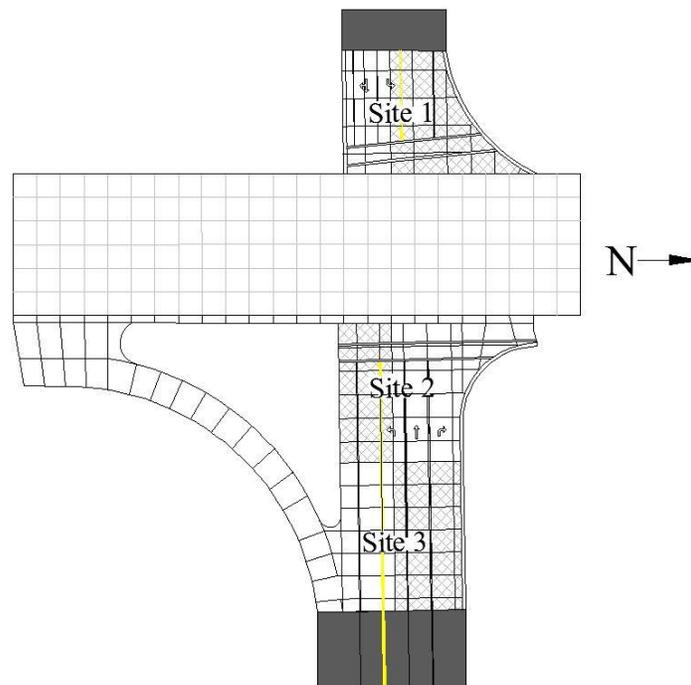
Figure 3-1: Intersection layout of 1000 West 1400 North.

UDOT directed construction of a new 9-in.-thick concrete pavement, reinforced with steel dowels and tie bars, along 1000 West in Logan, Utah, during the summer of 2013. At the intersection of 1000 West and 1400 North, one section each of typical and darkened concrete pavement was placed on the west side, while two sections each of typical and darkened concrete pavement were placed on the east side. These sections were labeled as sites 1 through 3 as illustrated in Figure 3-1. In Figures 3-1, 3-2, and 3-3, the absence of hatching and shading indicates a typical concrete section, hatching indicates a darkened concrete section, and solid gray indicates asphalt pavement.

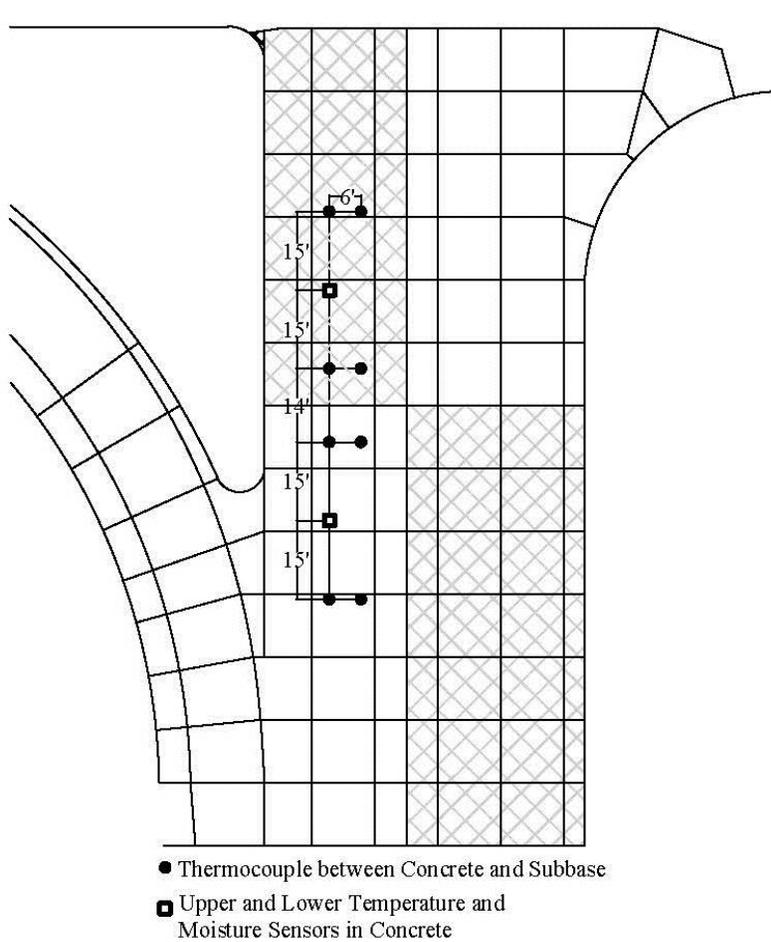
Figure 3-3: Sites 2 and 3 sensor and thermocouple layout.

Both the typical and the darkened concrete pavement sections were instrumented with temperature and moisture sensors, as shown in Figures 3-2 and 3-3, to enable monitoring of surface and subsurface temperatures and moisture contents at hourly intervals. At one typical and one darkened concrete pavement section on each side of the intersection, one location within a wheel path was selected for installation of sensors at the top and bottom of the concrete slab; measuring temperature and moisture at both the top and bottom of the concrete slabs allowed for computation of the temperature and moisture gradients at the selected locations. To position the sensors at the desired depths, the researchers mounted them on non-conductive plastic stakes secured in the subbase prior to concrete placement as shown in Figure 3-4; the sensors were 1.25 in. in height and were placed 7.25 in. apart so that approximately 0.25 in. of clear space would exist between the sensors and the top and bottom of the concrete slab. The sensor cables were carefully routed through 0.75-in.-diameter polyvinyl chloride (PVC) pipe that was buried just below the surface of the subbase layer as shown in Figure 3-5. On each side of the intersection,

of the same sections; the layouts of these thermocouples are shown in Figures 3-2 and 3-3. In each section, two thermocouples were placed in the same wheel path as the sensors mounted to the stake, while the other two thermocouples were placed in the other wheel path. The thermocouple wires were housed in PVC pipe or protective foam sleeves and routed to the same utility boxes where they could be easily accessed for manual reading during site visits by the researchers.

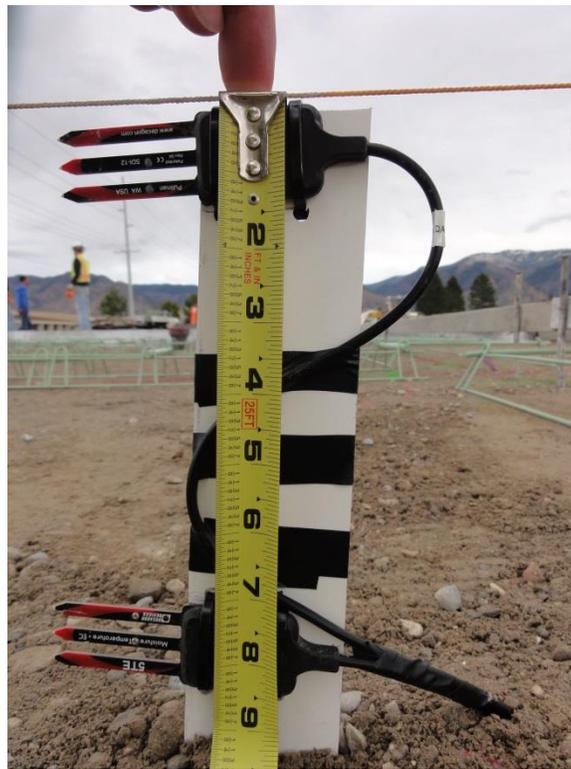
Figure 3-4: Temperature and moisture sensors for monitoring concrete pavement.

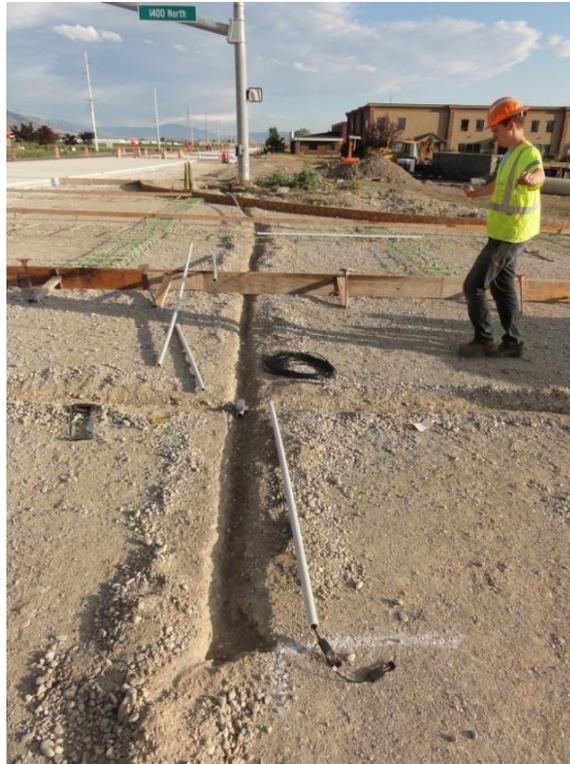
Figure 3-5: Sensor cables in PVC pipe.

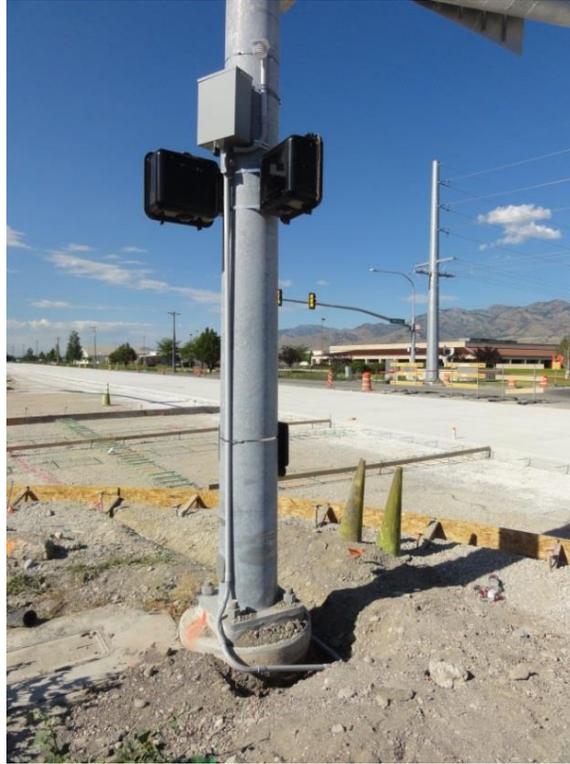
Figure 3-6: Utility box mounted on signal pole.

the PVC pipe conveyed the cables from the sensor locations to a nearby signal pole, where the cables were terminated in a steel utility box mounted approximately 12 ft high as shown in Figure 3-6.

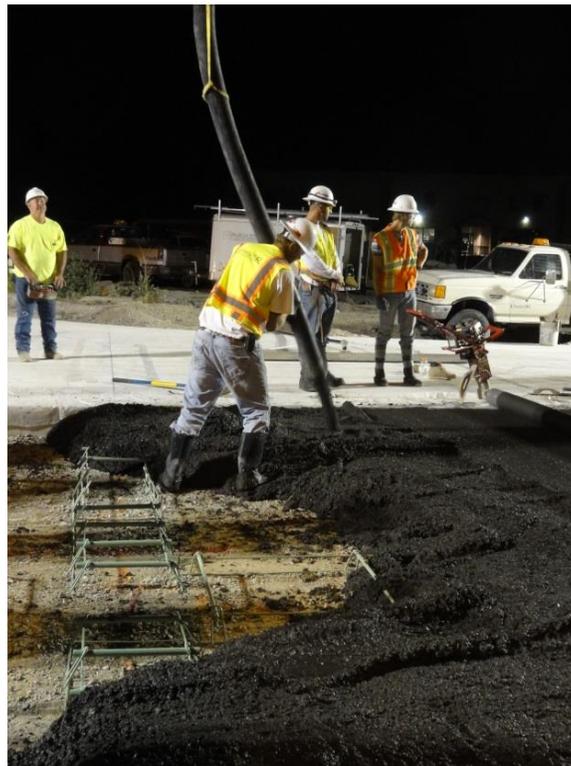
Figure 3-7: Placement of darkened concrete.

Concrete was placed on the west and east sides of the intersection during July and September 2013, respectively. Figure 3-7 shows placement of the darkened concrete in site 2. A concrete sample was collected in a wheelbarrow from the pump hose immediately after concrete was placed around the temperature and moisture sensors previously placed in each of the instrumented sections; this practice ensured that the sampled concrete was representative of the concrete surrounding the sensors. The researchers cast 10 4-in. by 8-in. cylinders of each type of concrete on each side of the intersection during placement. In addition, the researchers cast two

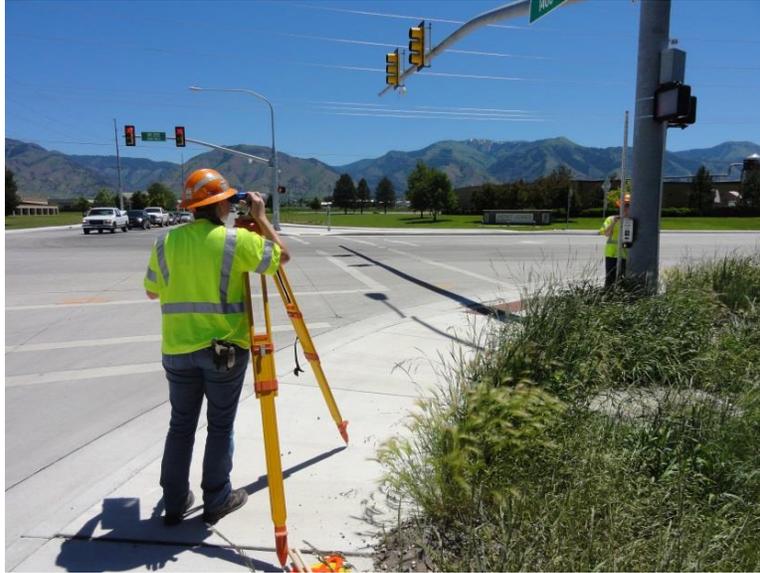
Figure 3-8: Measurement of roadway elevations.

Transverse and longitudinal slopes were measured during June 2015 using surveying equipment, as shown in Figure 3-8. Elevations were measured around the perimeter of the main lanes in each section at 5-ft intervals in the transverse direction and at 10-ft intervals in the longitudinal direction.

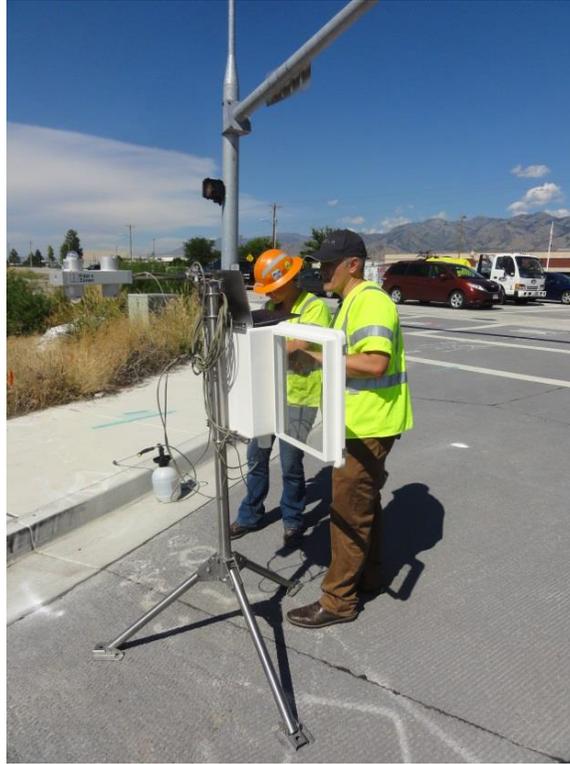
Figure 3-9: Measurement of pavement albedo.

A total of six readings were taken in each of the typical and darkened concrete sections within site 1. Within each section, three test locations were established, and testing in both the dry and wet conditions was performed at each test location. For the typical section, testing was performed at 10-ft intervals along a line extending east from a point approximately 3 ft north of the southwest corner of the section. For the darkened section, testing was performed at 10-ft intervals along a line extending east from a point approximately 3 ft south of the northwest corner of the section. After the first reading was taken with the pavement in a dry condition, the measurement area was sprayed with water, and a second reading was taken in a wet condition;

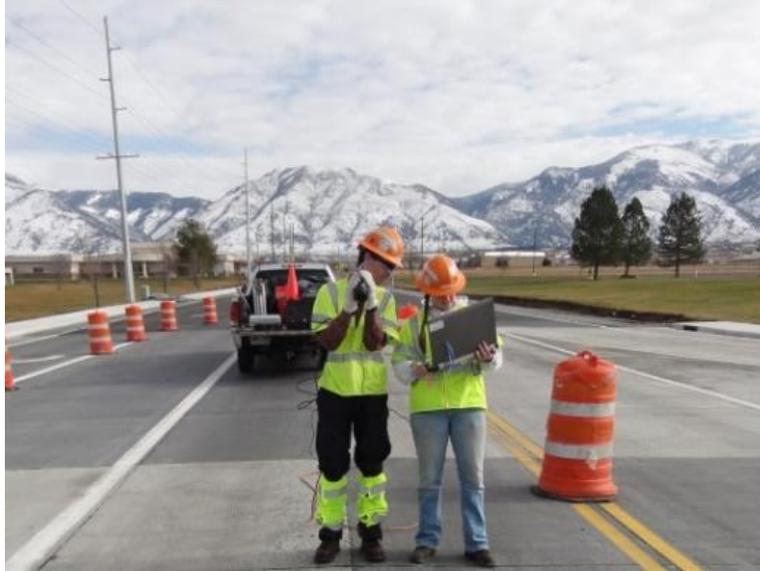
Figure 3-10: Measurement of surface temperatures using infrared thermography.

On regular intervals, the researchers documented surface temperatures using infrared thermography, as shown in Figure 3-10. The infrared photographs were mainly focused on the instrumented regions of the pavement so that the surface temperatures measured using the infrared thermography would be spatially correlated to the subsurface temperatures measured using thermocouples. The infrared images were analyzed using commercial software to determine average pavement surface temperatures in the regions of interest.

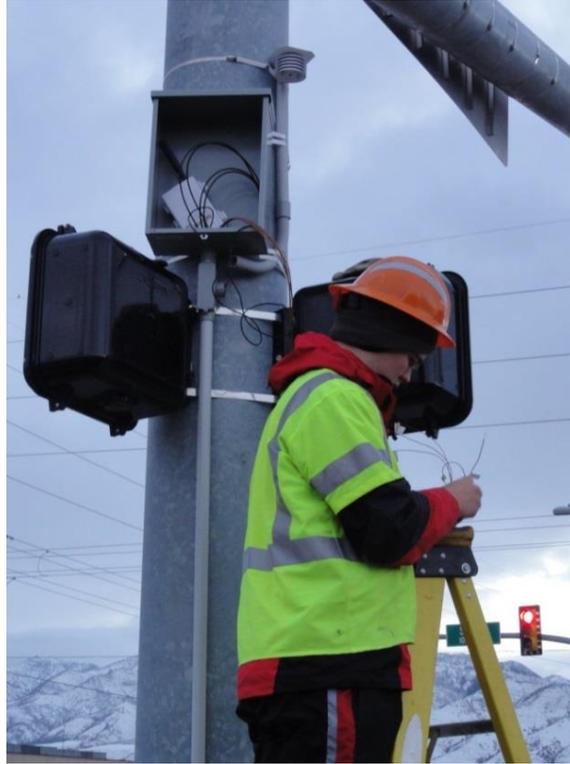
Figure 3-11: Measurement of subsurface temperatures using a thermocouple reader.

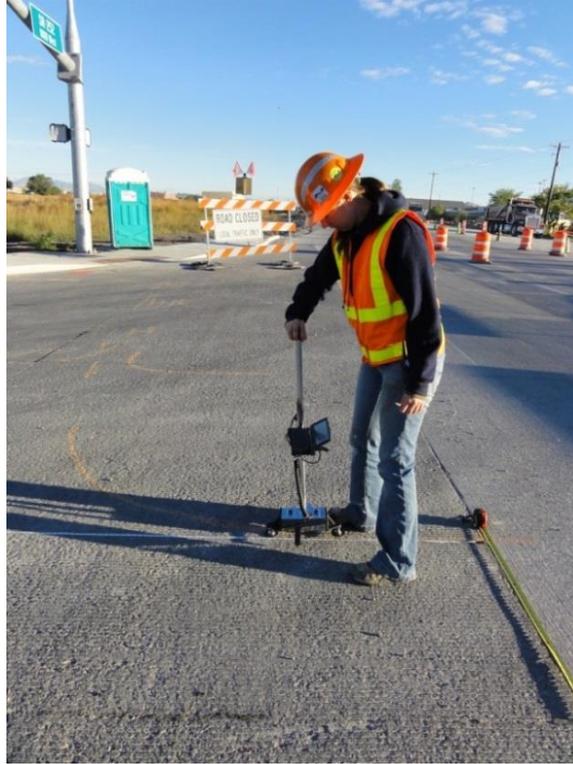
Figure 3-12: Measurement of pavement roughness using a roadway profiler.

On regular intervals, pavement roughness surveys were performed in general accordance with ASTM E1364 (Standard Test Method for Measuring Road Roughness by Static Level Method) using a roadway profiler in the wheel paths of each section, as shown in Figure 3-12. To ensure that the survey began in exactly the same location and proceeded along the same line in each case, the researchers permanently marked the beginning and ending points of each line and the exact placement of the profiler at the beginning point, as shown in Figure 3-13. This process ensured that variability between successive measurements in the same wheel path could be attributed to either temperature curling and/or moisture warping of the tested slab.

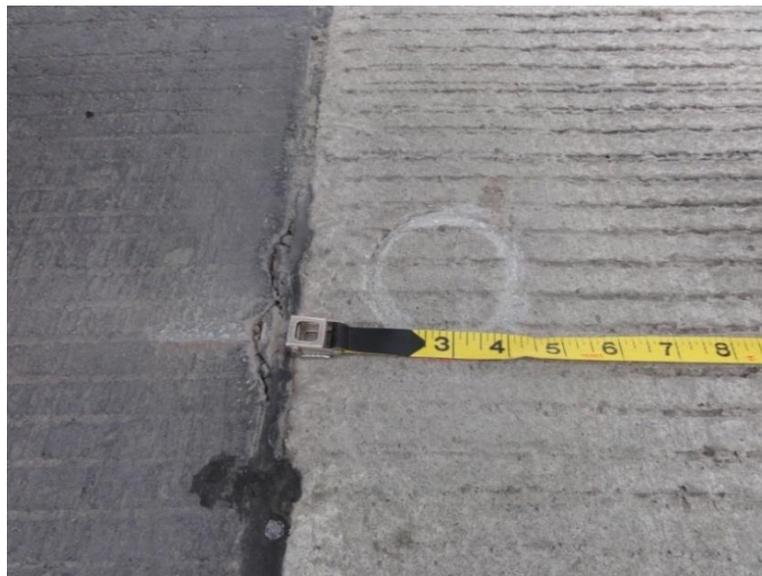
Figure 3-13: Marked beginning point on pavement for roughness survey.

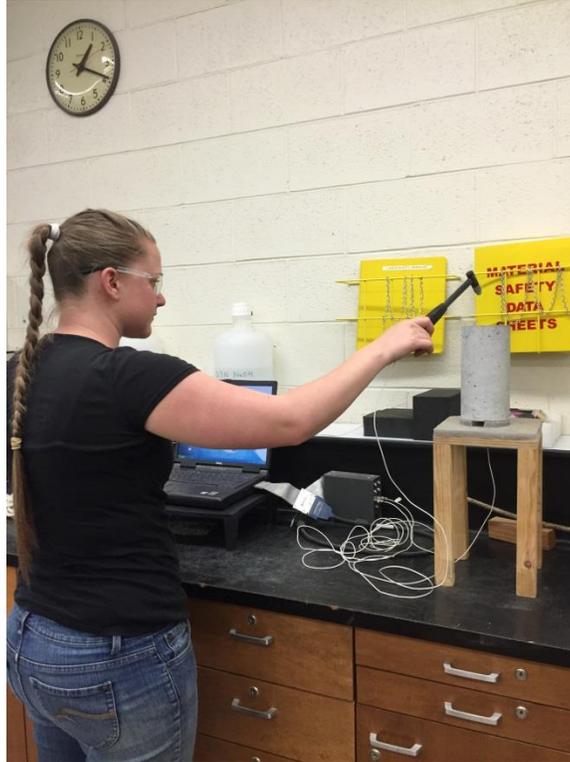
Figure 3-14: Elastic modulus testing.

E = elastic modulus (psi)
 γ = density (lb/ft³)
 l = length (ft)
 f = frequency (Hz)

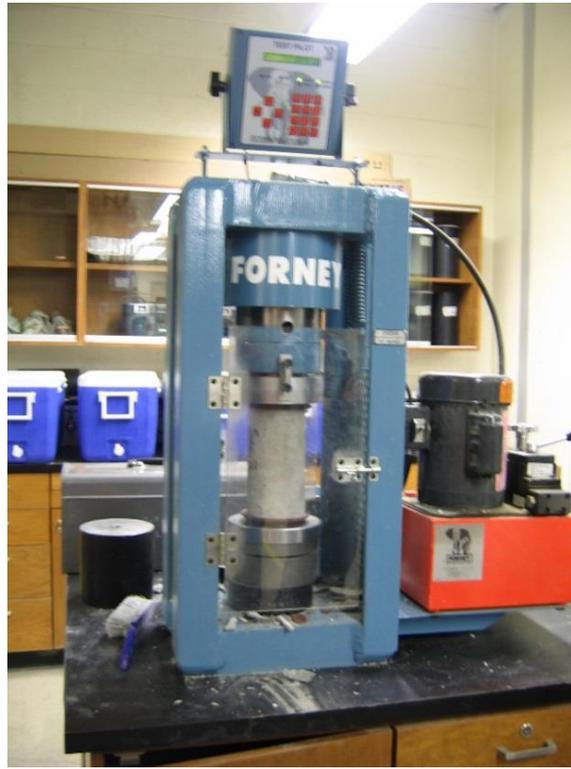
Figure 3-15: Compressive strength testing.

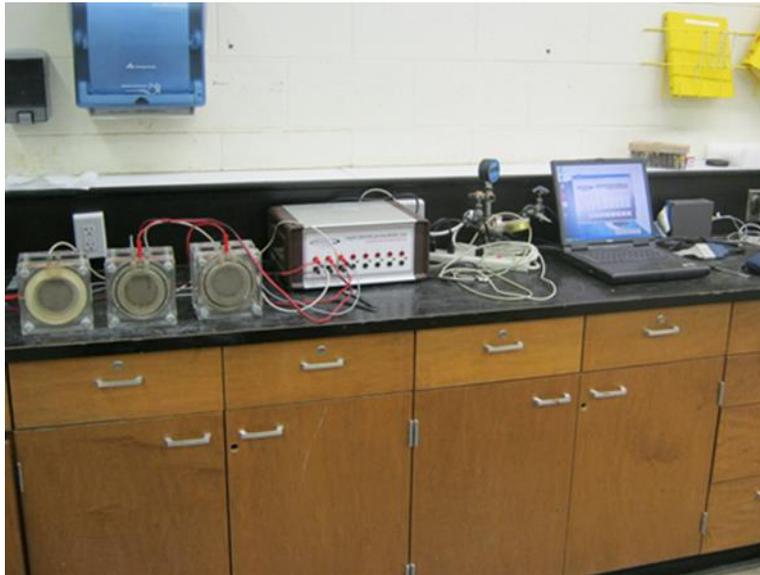
Figure 3-16: Rapid chloride permeability testing apparatus.

thickness of 2 in. from the middle of the cylinders using a masonry saw, so that three samples per cylinder were obtained. The samples were then saturated for a period of 24 hours in de-aired, de-ionized water. After the conditioning period was complete, the opposite faces of each specimen were exposed to solutions of sodium hydroxide and sodium chloride while a 60V potential was imposed over the length of the specimen. During the 6-hour test, the total charge, in coulombs, that passed through the specimen was measured, and the concrete permeability was classified according to the threshold values presented in Table 3-1. The rapid chloride permeability testing apparatus is shown in Figure 3-16.

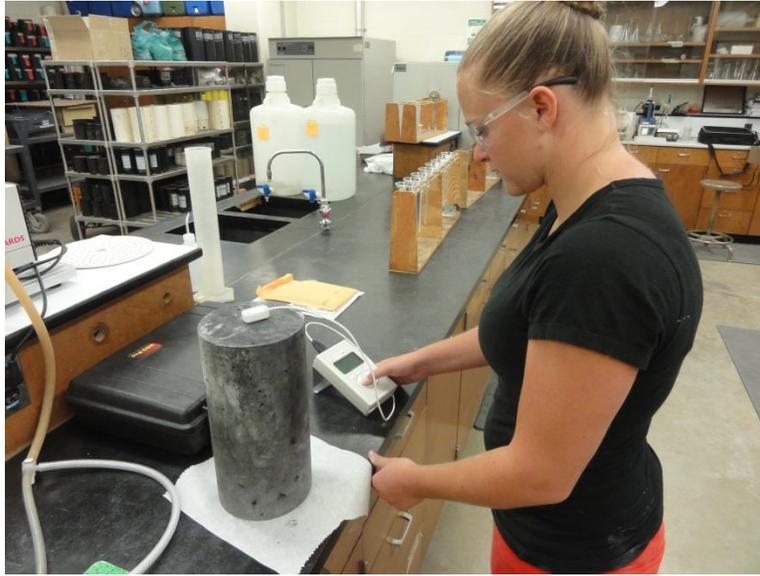
Figure 3-17: Thermal conductivity testing.

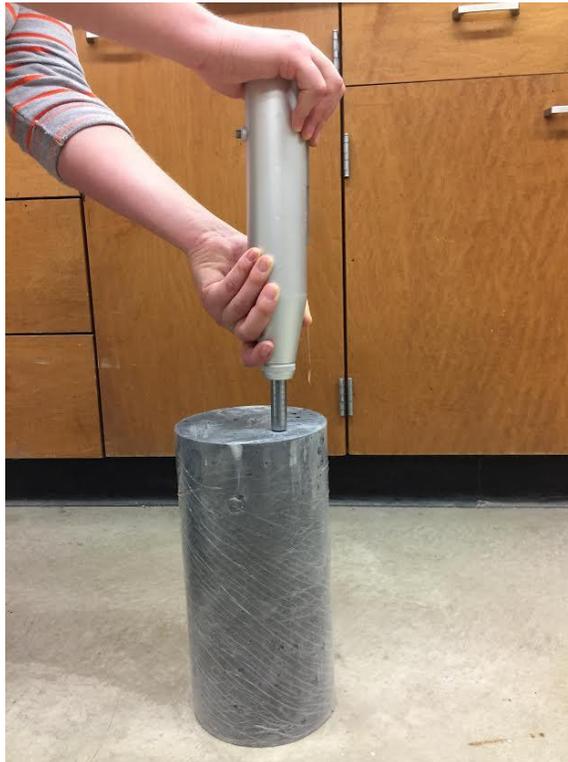
Figure 3-18: Schmidt rebound hammer testing.

Schmidt rebound hammer tests were performed on the same cylinders used in thermal conductivity testing and in the same conditions, including wet, dry, low-temperature, and high-temperature conditions. Before the first test was performed, three locations were marked on both the top and the bottom of each cylinder, and one Schmidt rebound hammer test was performed at each of the marked locations, for a total of six tests per cylinder in each of the four conditions. Schmidt rebound hammer testing of a darkened concrete cylinder in the dry condition is shown in Figure 3-18.

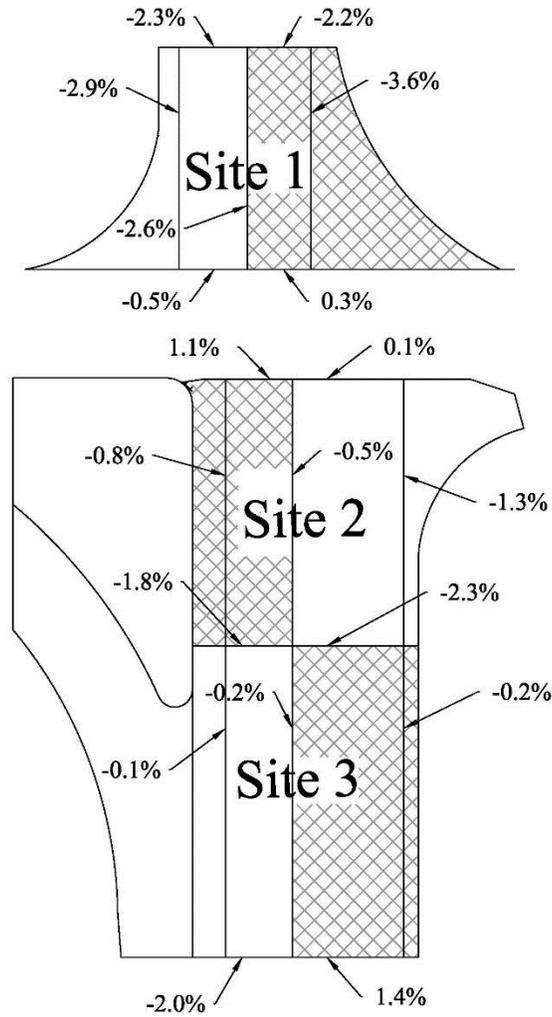
Figure 4-1: Transverse and longitudinal slopes.

Elevation surveys were performed to measure both the average transverse and longitudinal slopes at each test site. Figure 4-1 shows the average transverse slopes for all sites along the east and west sides of the main lanes as well as the average longitudinal slopes for all sites along the north and south sides of the main lanes in each section. For the transverse surveys, the slopes were calculated with respect to the elevation of the crown at each site; therefore, a positive transverse slope indicates that the pavement sloped upward toward the outer edge of the section, while a negative transverse slope indicates that the pavement sloped downward toward the outer edge of the section. For the longitudinal surveys, the slopes were calculated with respect to the edge of the pavement closest to the intersection, meaning the east edge of site 1 and the west edges of sites 2 and 3; therefore, a negative longitudinal slope indicates that the pavement sloped downward away from the intersection. The variable slope measurements suggest that not all of the sections were planar and that not all of the sections experienced consistent solar radiation intensity during all seasons due to the non-zero zenith angle in this region. The occurrence of varying transverse and longitudinal pavement slopes ensured that the data were representative of typical roads.

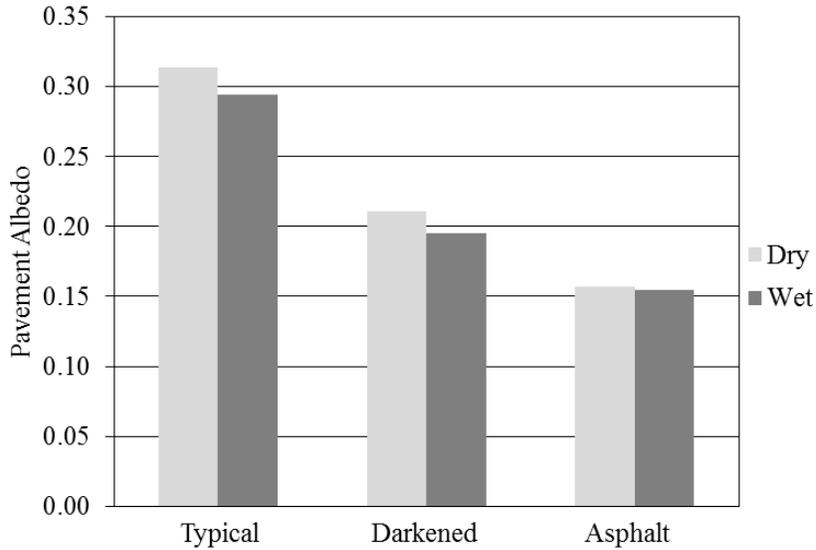
Figure 4-2: Pavement albedo.

The results of albedo testing were averaged by section and condition, as shown in Figure 4-2. The average albedo for the darkened concrete pavement was lower than the average albedo of the typical concrete pavement by 0.099 to 0.103, or 33 to 34 percent, and was higher than the average albedo of the asphalt pavement by 0.041 to 0.054, or 26 to 34 percent, depending on the pavement condition. Thus, while the use of the iron oxide pigment in the darkened concrete was successful in achieving a lower albedo than that of the typical concrete pavement, the albedo was still higher than that of the adjacent asphalt pavement at the time of testing.

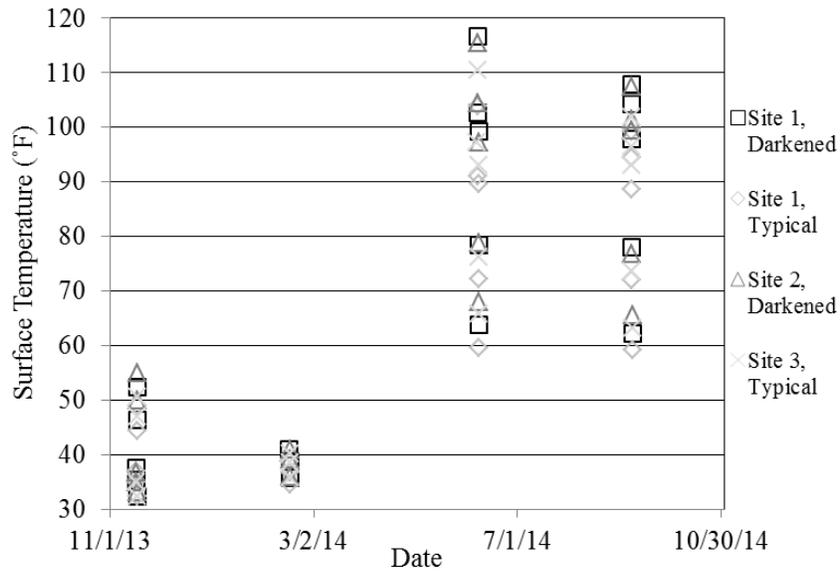
Figure 4-3: Surface temperatures measured using infrared thermography.

Surface pavement temperatures were calculated from the infrared images by averaging the temperature measurements at the approximate locations of the four thermocouples in each instrumented section. As shown in Figure 4-3, measurements in each section were made at four

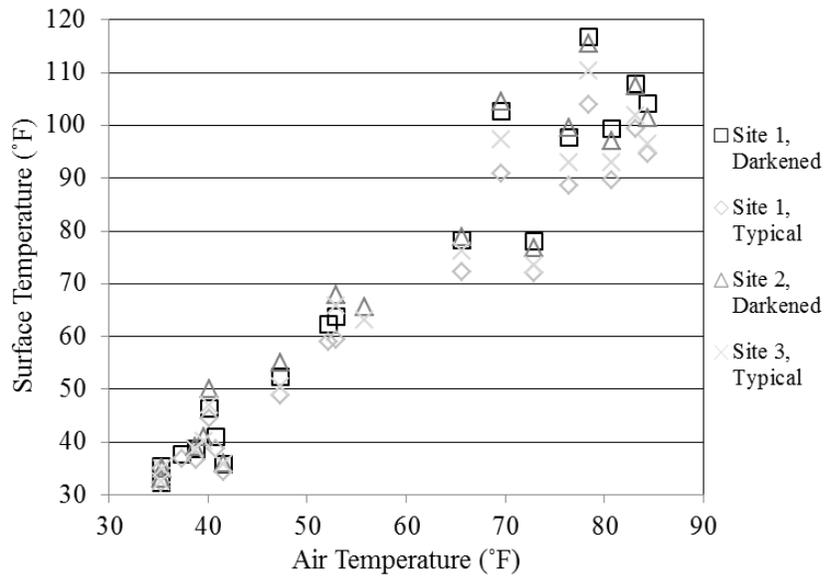
Figure 4-4: Air temperature from data logger readings compared to pavement surface temperatures from infrared thermography.

Figures 4-4 and 4-5 show correlations between air temperature readings and surface temperature readings. As explained previously, the sensors and thermocouples for sites 2 and 3 were placed only in the south side of the roadway, which consisted of darkened pavement in site 2 and typical pavement in site 3, as shown in Figure 3-3. A strong positive correlation exists between the air temperature and the surface pavement temperatures, as shown in Figure 4-4. Differences in surface pavement temperatures between the typical and darkened concrete sections were calculated by subtracting the value of the typical concrete from the value of the darkened concrete. Figure 4-5 shows that the difference between the surface temperatures of the darkened and typical pavements decreases as the air temperature decreases. Indeed, the results of a linear regression analysis suggest that, when the air temperature is 32°F, the surface temperature of the darkened concrete is just 0.2°F higher than that of the typical concrete, and the difference is expected to be 0°F when the air temperature is 30.5°F. Therefore, the darkened pavement is unlikely to melt snow and ice faster than the typical pavement for conditions similar to those in this research.

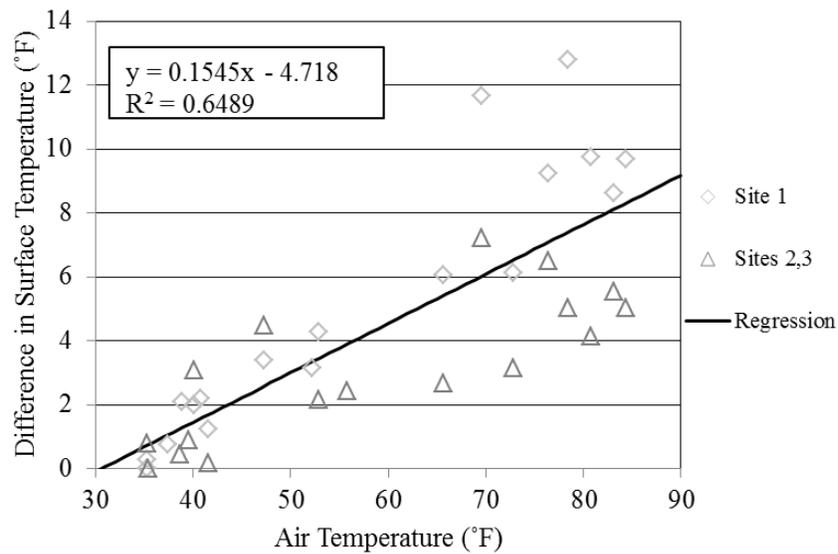
Figure 4-5: Air temperature from data logger readings compared to differences in pavement surface temperatures from infrared thermography.

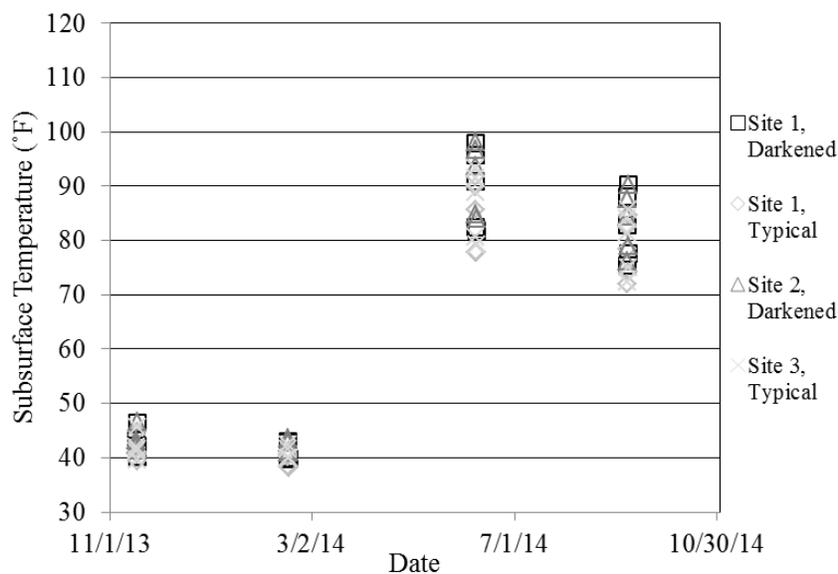
Figure 4-6: Subsurface temperatures measured using thermocouples.

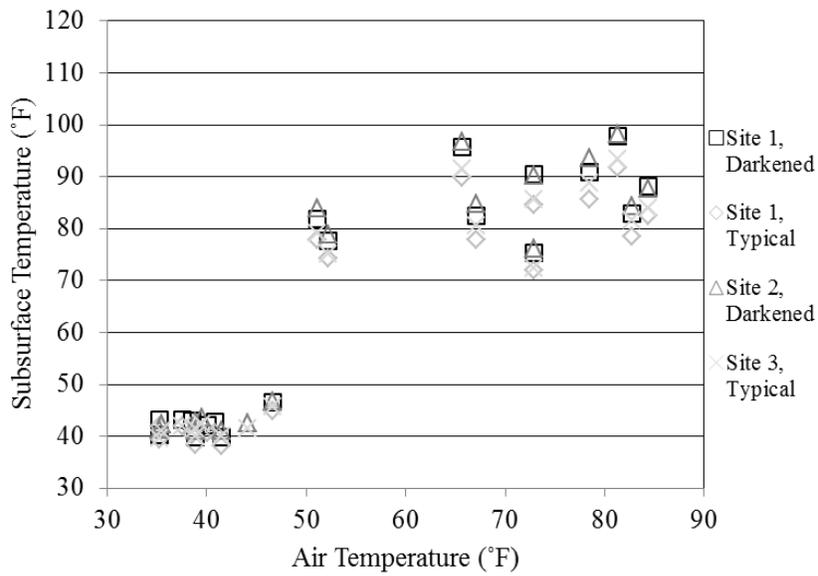
Figure 4-7: Air temperature from data logger readings compared to pavement subsurface temperature from thermocouple readings.

Figures 4-7 and 4-8 show correlations between air temperature readings and subsurface temperature readings. A strong positive correlation exists between the air temperature and the subsurface pavement temperatures, as shown in Figure 4-7. Differences in subsurface pavement temperatures between the typical and darkened concrete sections were calculated by subtracting the value of the typical concrete from the value of the darkened concrete. Figure 4-8 shows that the difference between the subsurface temperatures of the darkened and typical pavements also

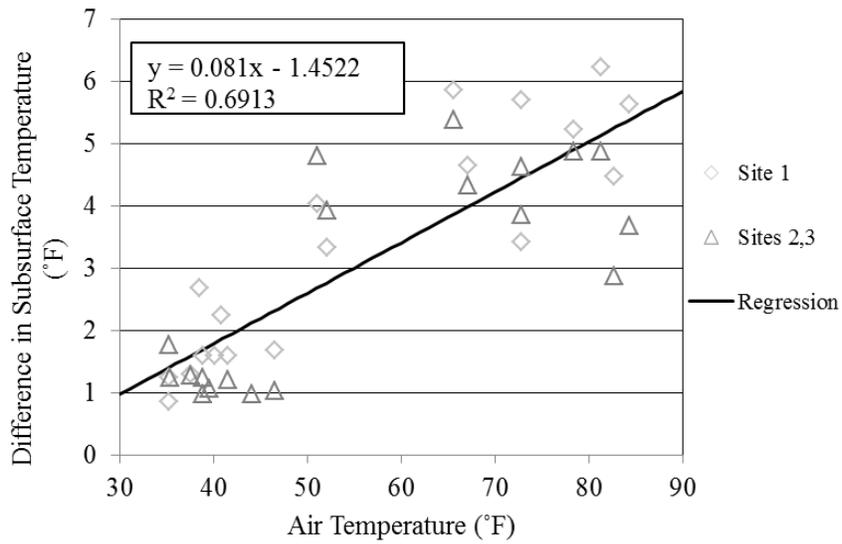
Figure 4-8: Air temperature from data logger readings compared to differences in pavement subsurface temperatures from thermocouple readings.

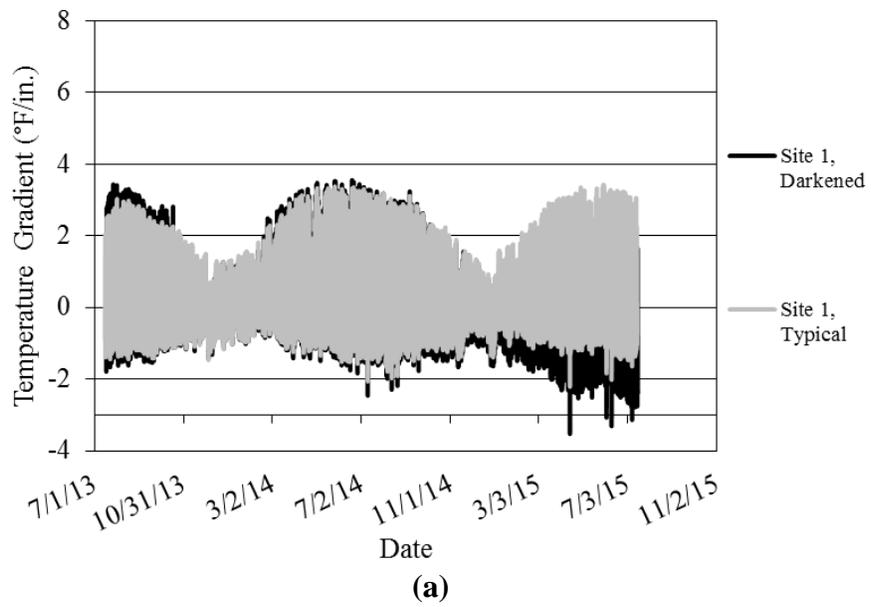
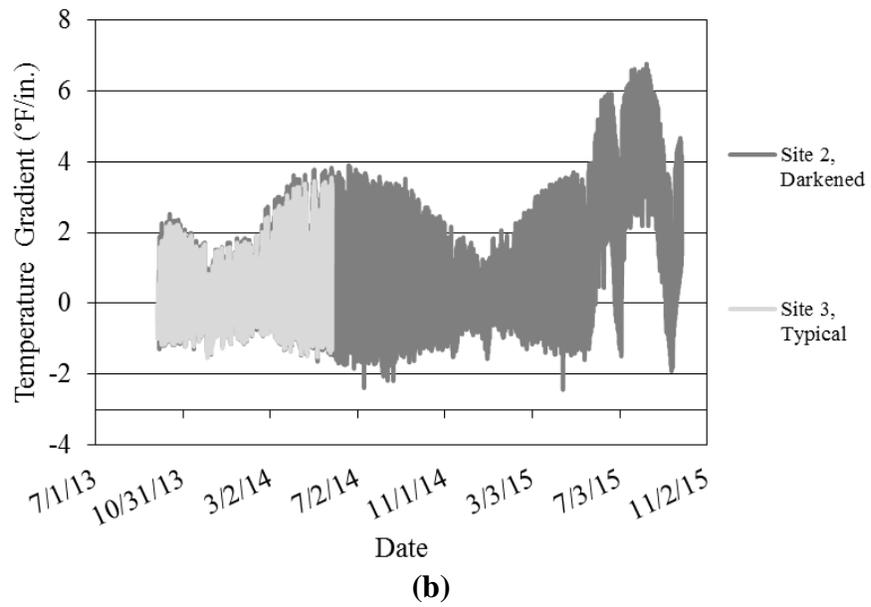
Figure 4-9: Temperature gradients for (a) site 1 and (b) sites 2 and 3.

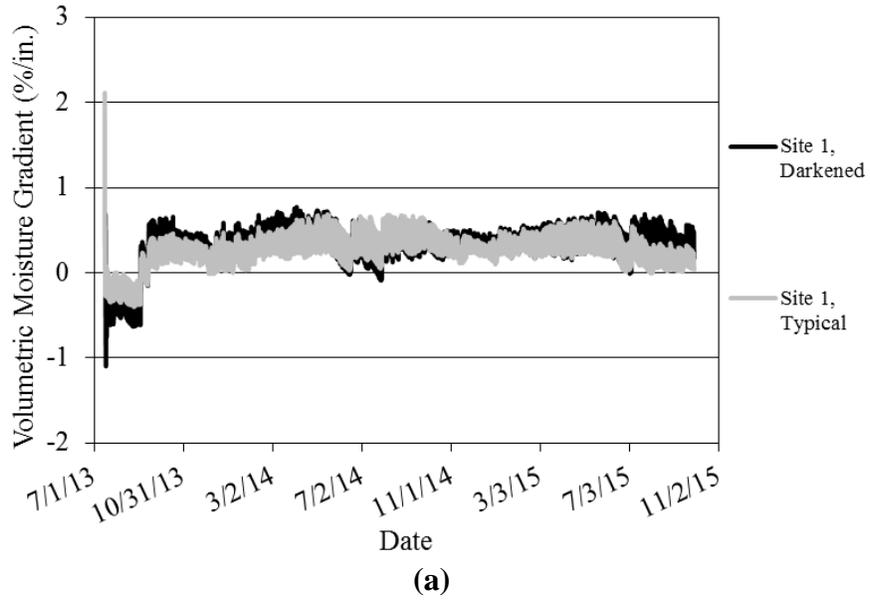
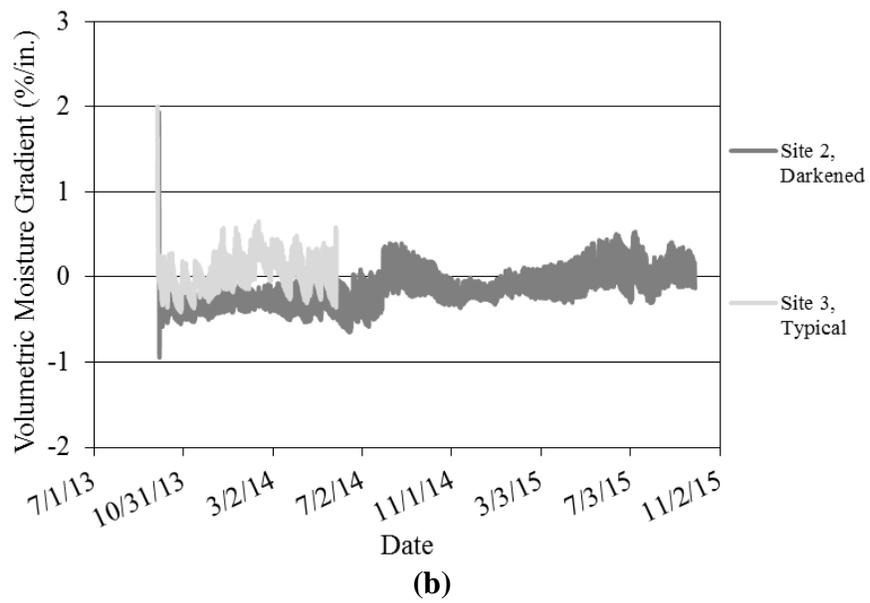
Figure 4-10: Moisture gradients for (a) site 1 and (b) sites 2 and 3.

Figure 4-10 shows moisture gradients determined using the moisture sensors. Moisture gradients were calculated from sensor readings obtained through the data loggers by subtracting the values measured at a given time by the upper moisture sensor from the values measured at the same time by the lower moisture sensor and dividing by the vertical distance between the sensors. When considered over the entire monitoring period, the average pavement moisture gradient of the darkened pavement was higher than that of the typical pavement at site 1 by 0.041 %/in., or 17 percent, and lower than that of the typical pavement at sites 2 and 3 by 0.859 %/in., or 127 percent. (Due to the high ion concentrations typical of pore water in concrete, the

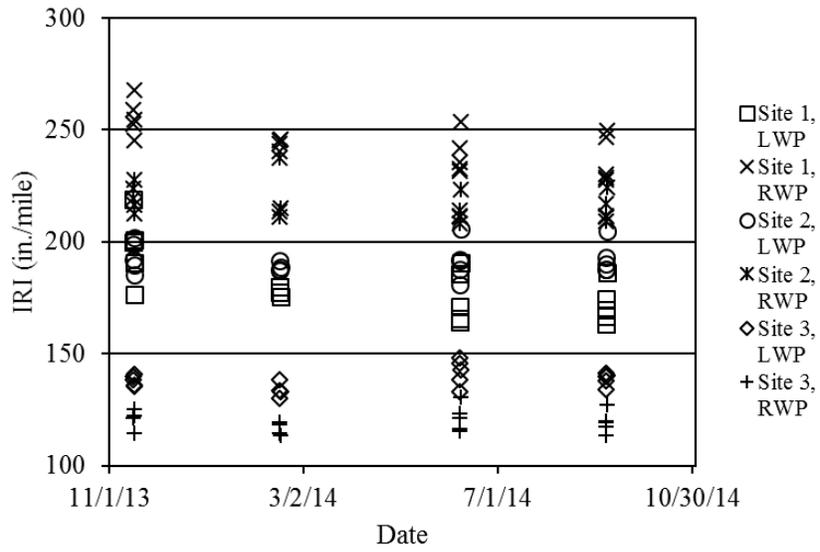
Figure 4-11: Roughness for all typical concrete sections.

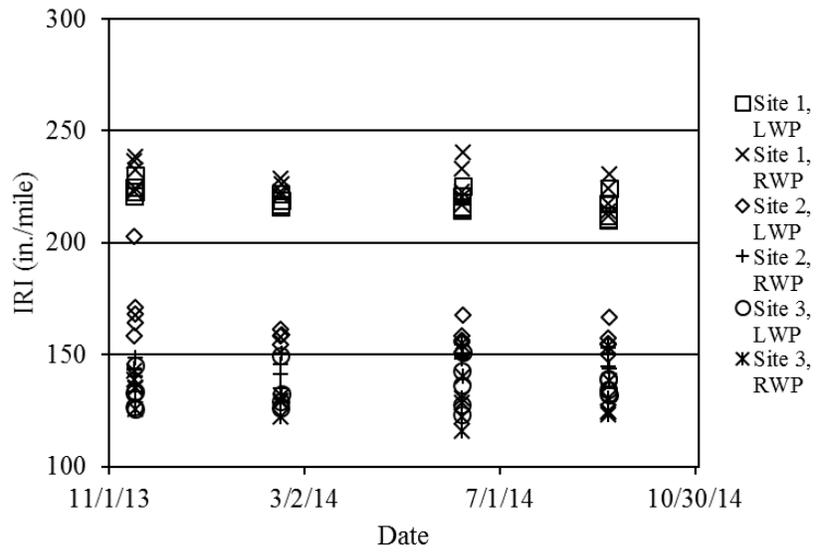
Figure 4-12: Roughness for all darkened concrete sections.

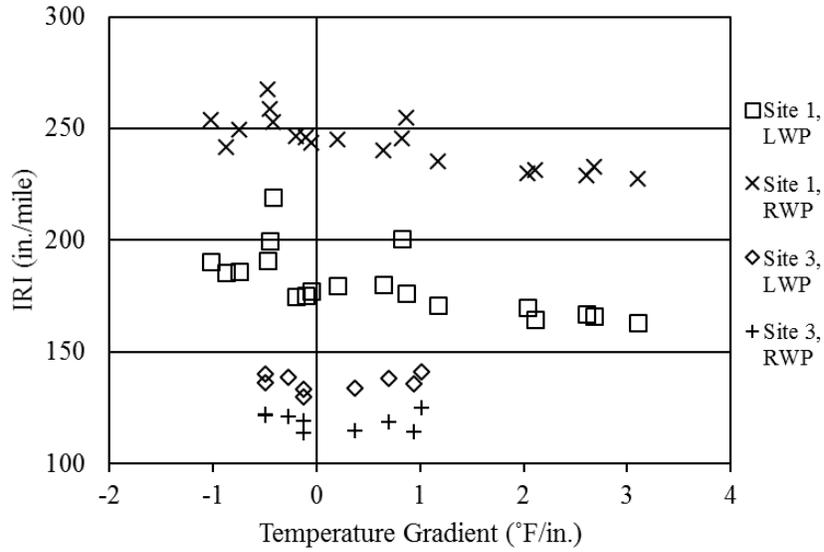
Figure 4-13: Roughness and temperature gradient for all instrumented typical concrete sections.

Figures 4-13 and 4-14 show pavement roughness plotted against temperature gradient for all wheel paths of all instrumented typical and darkened concrete sections, respectively, while Figures 4-15 and 4-16 show pavement roughness plotted against moisture gradient for all instrumented typical and darkened concrete sections, respectively. To investigate the effects of temperature and moisture gradients on roughness of the typical and darkened concrete pavements, the researchers performed a linear regression analysis for each unique combination of site, wheel path, and concrete type. Each analysis produced an equation in the form of $y = mx + b$, where y was roughness and x was either temperature gradient or moisture gradient. Roughness, temperature gradient, and moisture gradient were analyzed in units of in./mile, °F/in., and %/in., respectively. Table 1 presents the parameter estimates and corresponding p -values that were computed together with the coefficient of determination, or R^2 value, for each regression model. The null hypotheses tested in the regression analyses were that the estimates computed for the slope and intercept were not different than zero, while the alternative hypotheses were that the estimates were different than zero. P -values less than or equal to 0.05 indicated that sufficient evidence was available to reject the null hypothesis, while p -values greater than 0.05 indicated that sufficient evidence was not available to reject the null hypothesis. An R^2 value of 1.0 indicated a perfect model.

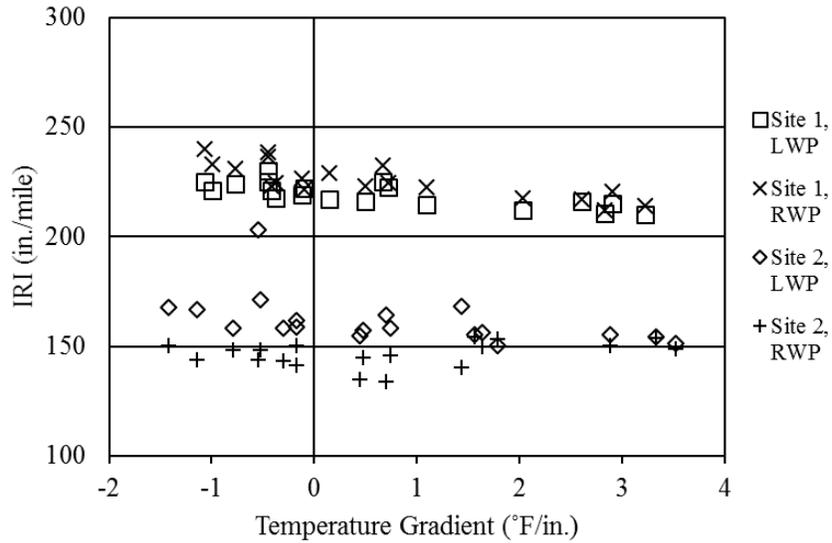
Figure 4-14: Roughness and temperature gradient for all instrumented darkened concrete sections.

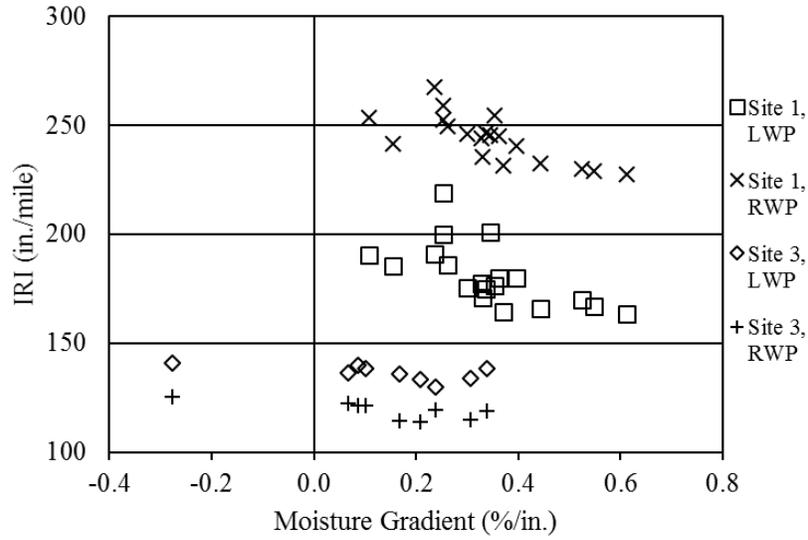
Figure 4-15: Roughness and moisture gradient for all instrumented typical concrete sections.

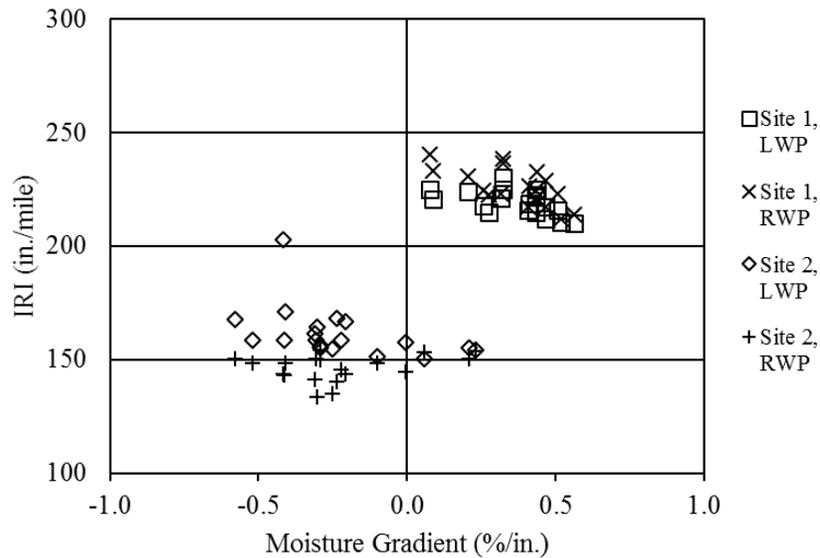
Figure 4-16: Roughness and moisture gradient for all instrumented darkened concrete sections.

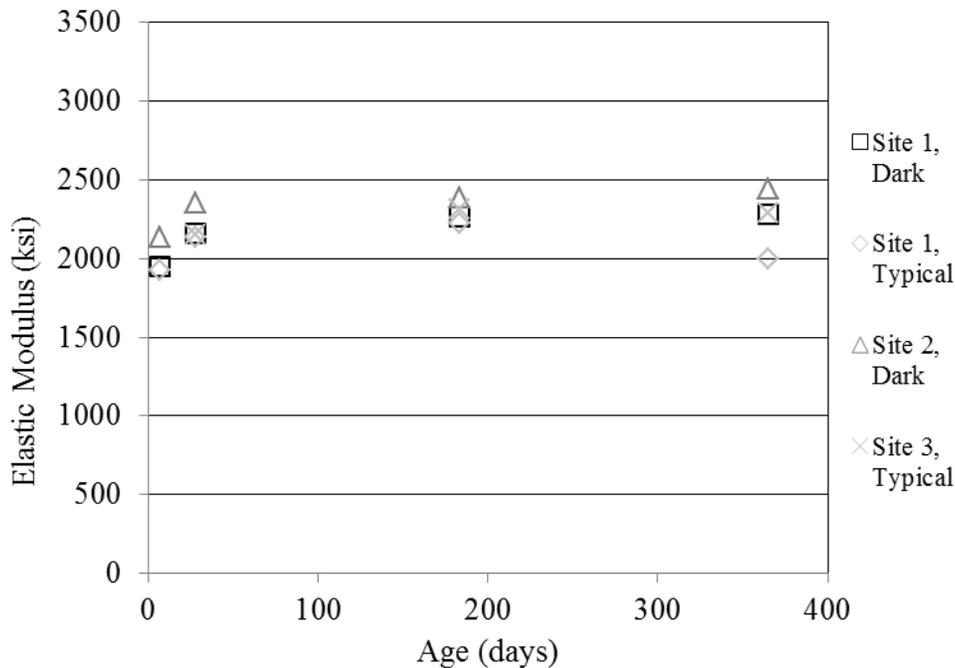
Figure 4-17: Average concrete elastic modulus.

Figure 4-17 shows average concrete elastic modulus values. Specific cylinder length, diameter, weight, density, frequency, and elastic modulus values are given in Appendix B. On average, the darkened concrete was stiffer than the typical concrete by 220 ksi, or 10.3 percent, at 1 year.

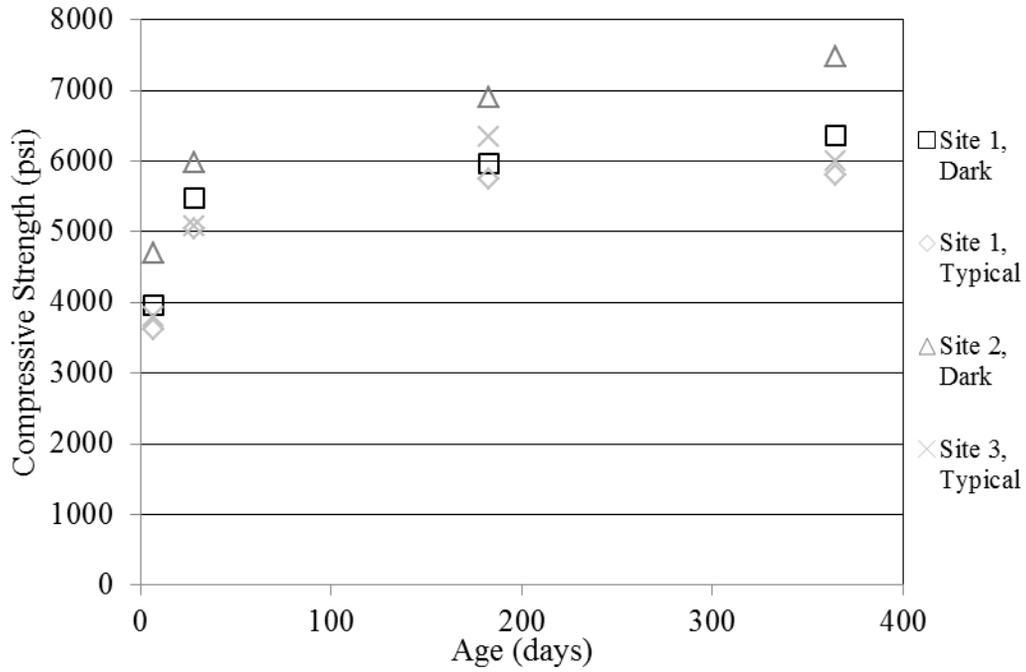
Figure 4-18: Concrete compressive strength.
